| <b>Project Name:</b><br>Gold King Mine | <b>Site Location:</b><br>Silverton, San Juan County, Colorado | <b>Project No.</b><br>0001/1408-01 |

## PHOTOGRAPH LOG

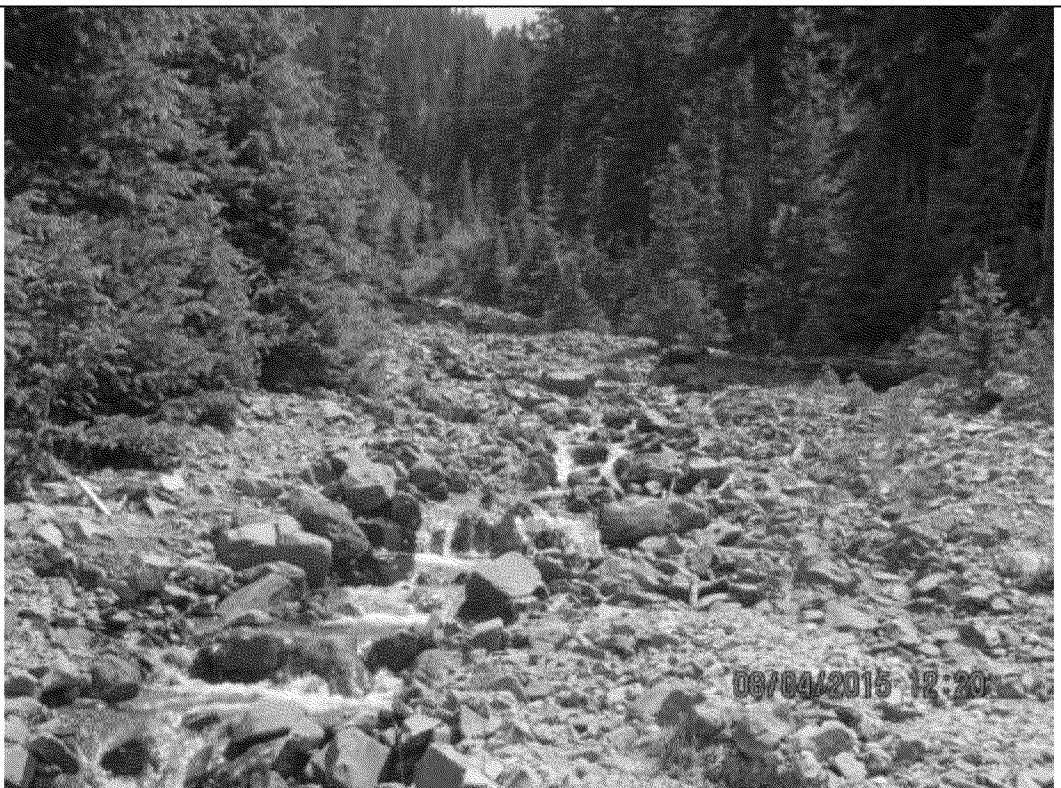
| <b>Photo No.</b><br><b>10</b> | <b>Date:</b><br>08/04/2015 | |

| <b>Description:</b><br>Water of the North Fork just upstream of Cement Creek. | | |

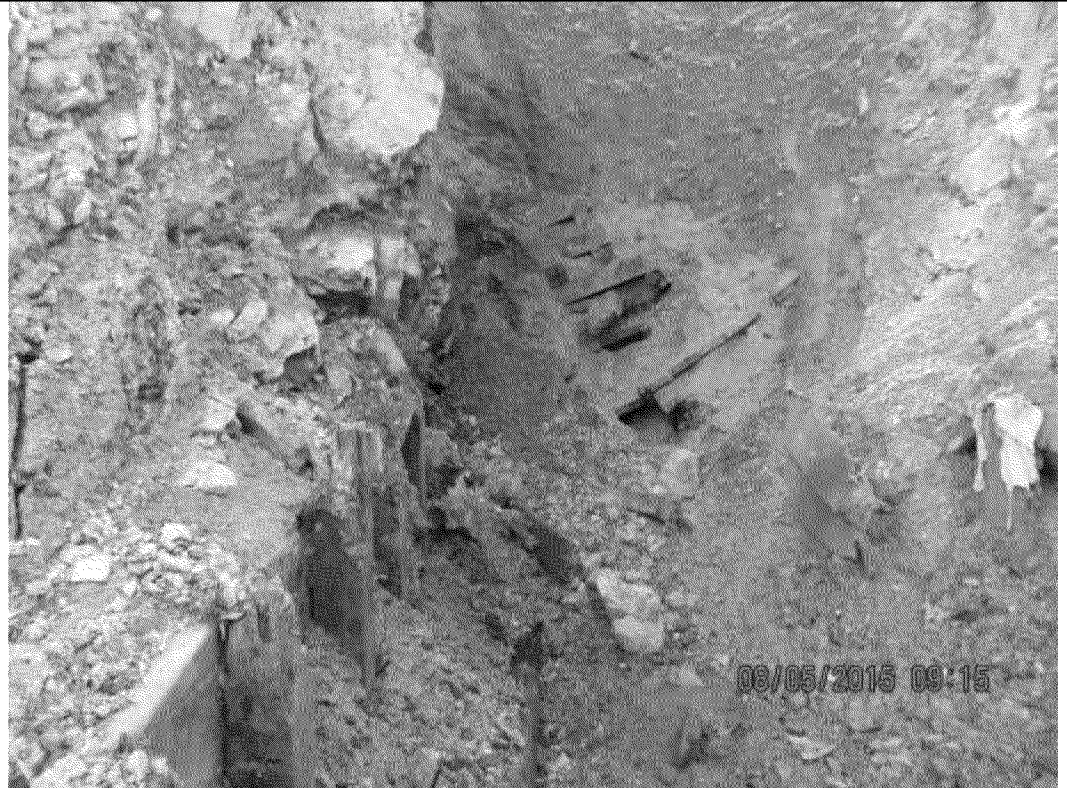
**Photo No.**  
**14**

Excavating material above the collapsed adit.

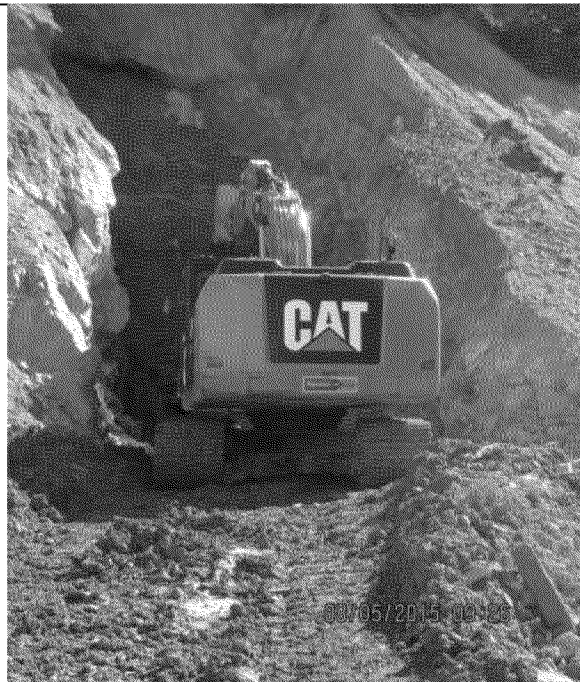
**Photo No.**  
**15**

Bedrock found above the anticipated adit.

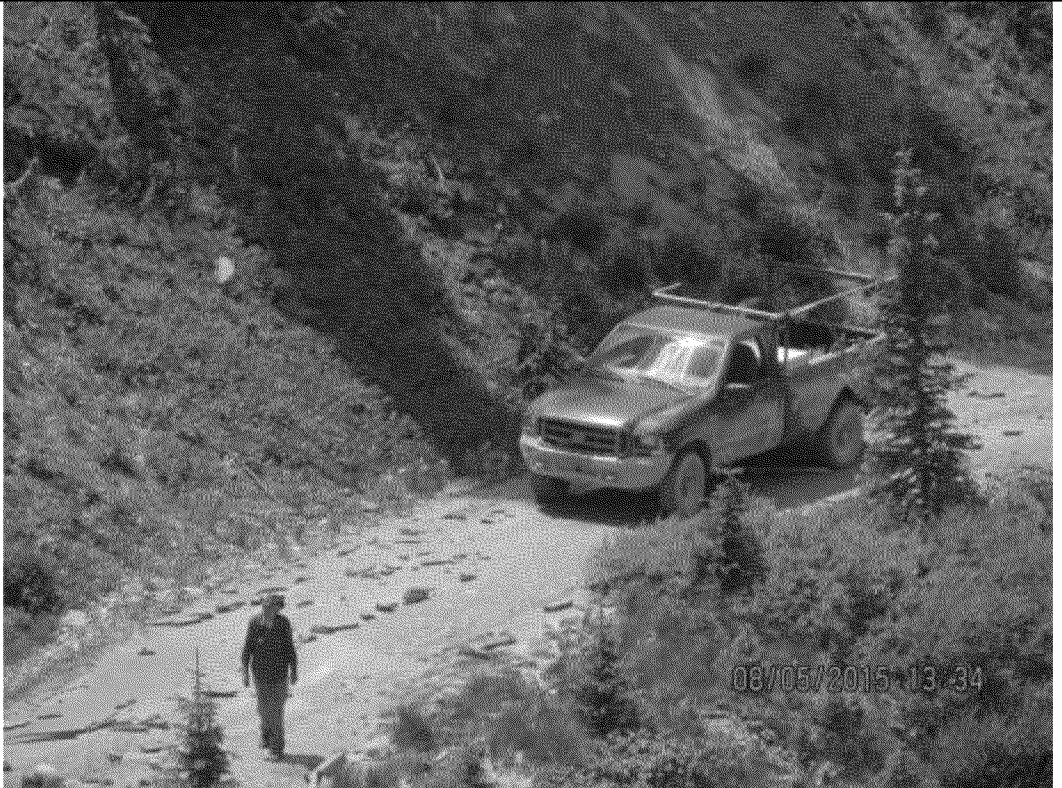
| <b>Photo No.</b><br>41 | <b>Date:</b><br>08/05/2015 | |

| <b>Description:</b><br>Noted visitor to the site, unknown person, walked up to excavator at North Fork crossing and then back to vehicle. | | |

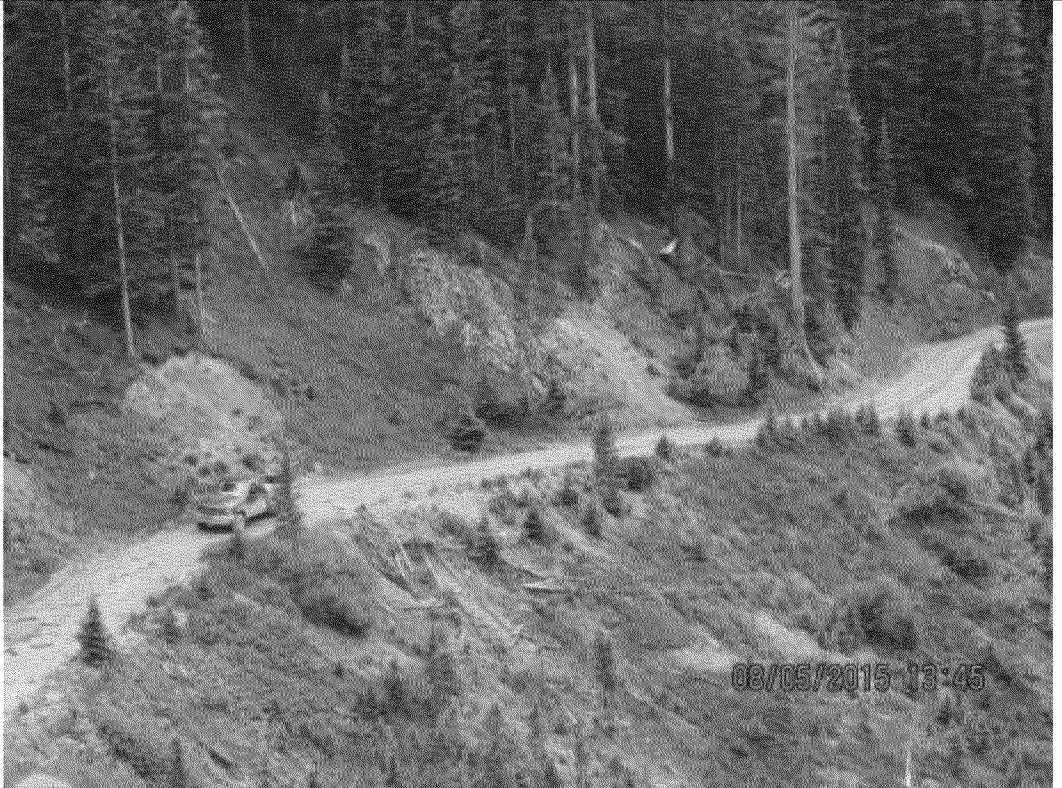
| <b>Photo No.</b><br>42 | <b>Date:</b><br>08/05/2015 | |

| <b>Description:</b><br>Visitor leaving. | | |

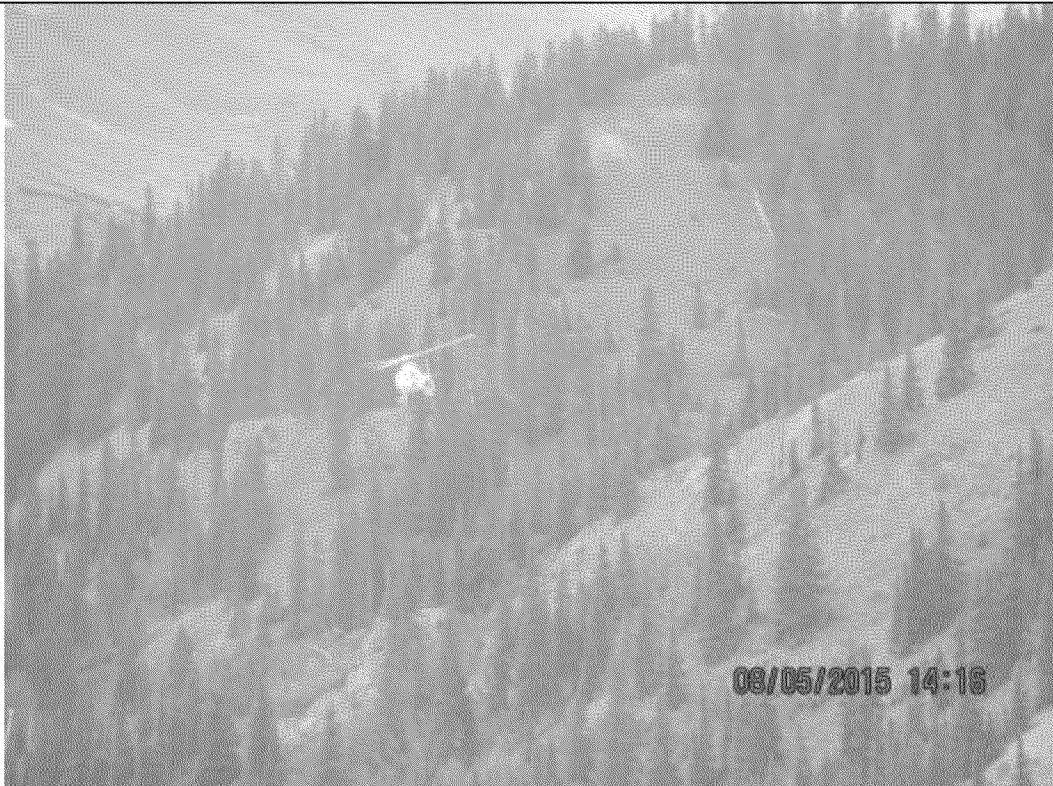
| <b>Photo No.</b><br><b>47</b> | <b>Date:</b><br>08/05/2015 | |

| <b>Description:</b><br>Close up of Flight for Life. | | |

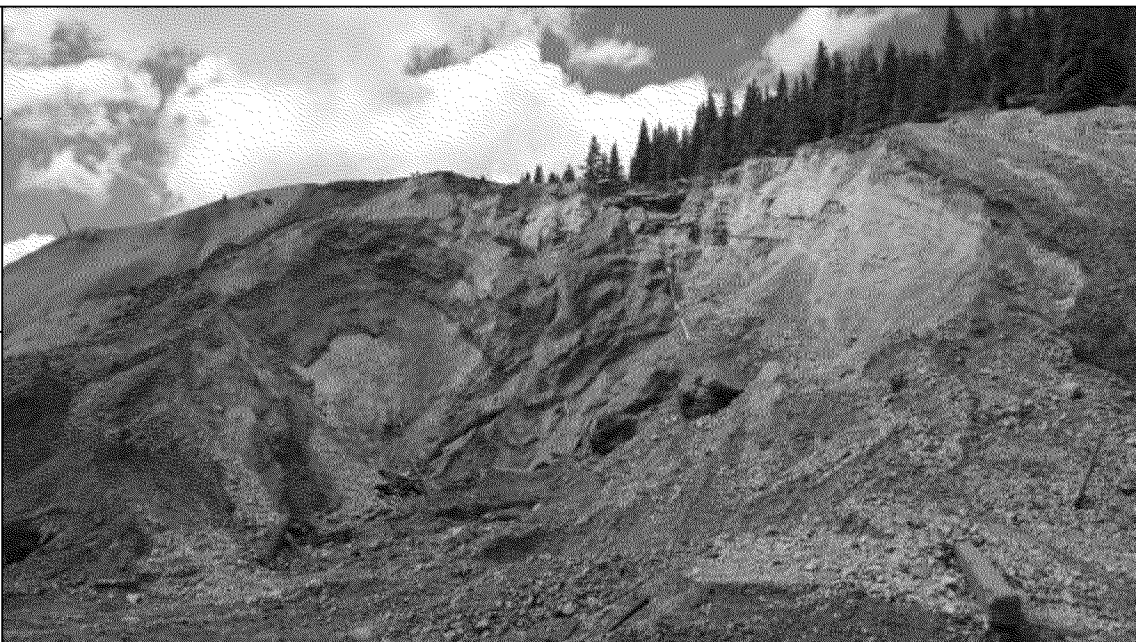
| <b>Photo No.</b><br><b>51</b> | <b>Date:</b><br>08/05/2015 | |

| <b>Description:</b><br>Looking up from the toe of the Gold King waste dump directly south of the adit. | | |

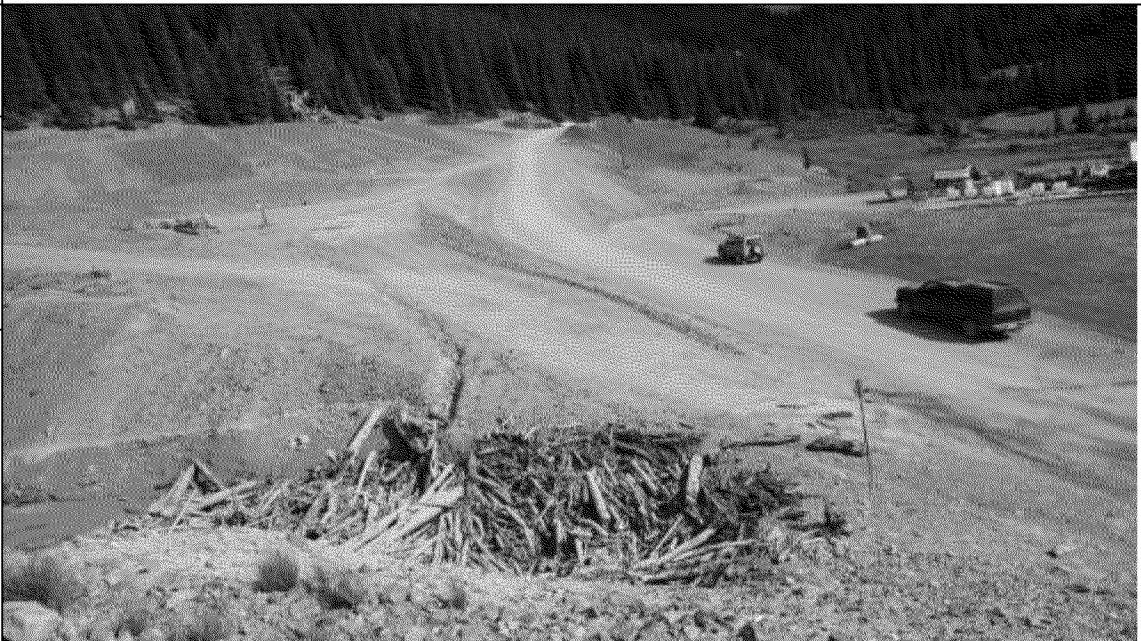
| <b>Photo No.</b><br><b>54</b> | <b>Date:</b><br>08/05/2015 | |

| <b>Description:</b><br><br>Cement Creek crossing at Gladstone. | | |
